RESTORATION OF AN ABANDONED GAS STATION IN NEW JERSEY USING BIOREMEDIATION: A CASE STUDY

Satya Ganti,¹ Dinkar Ganti²

INTRODUCTION - BROWNFIELD REMEDIATION

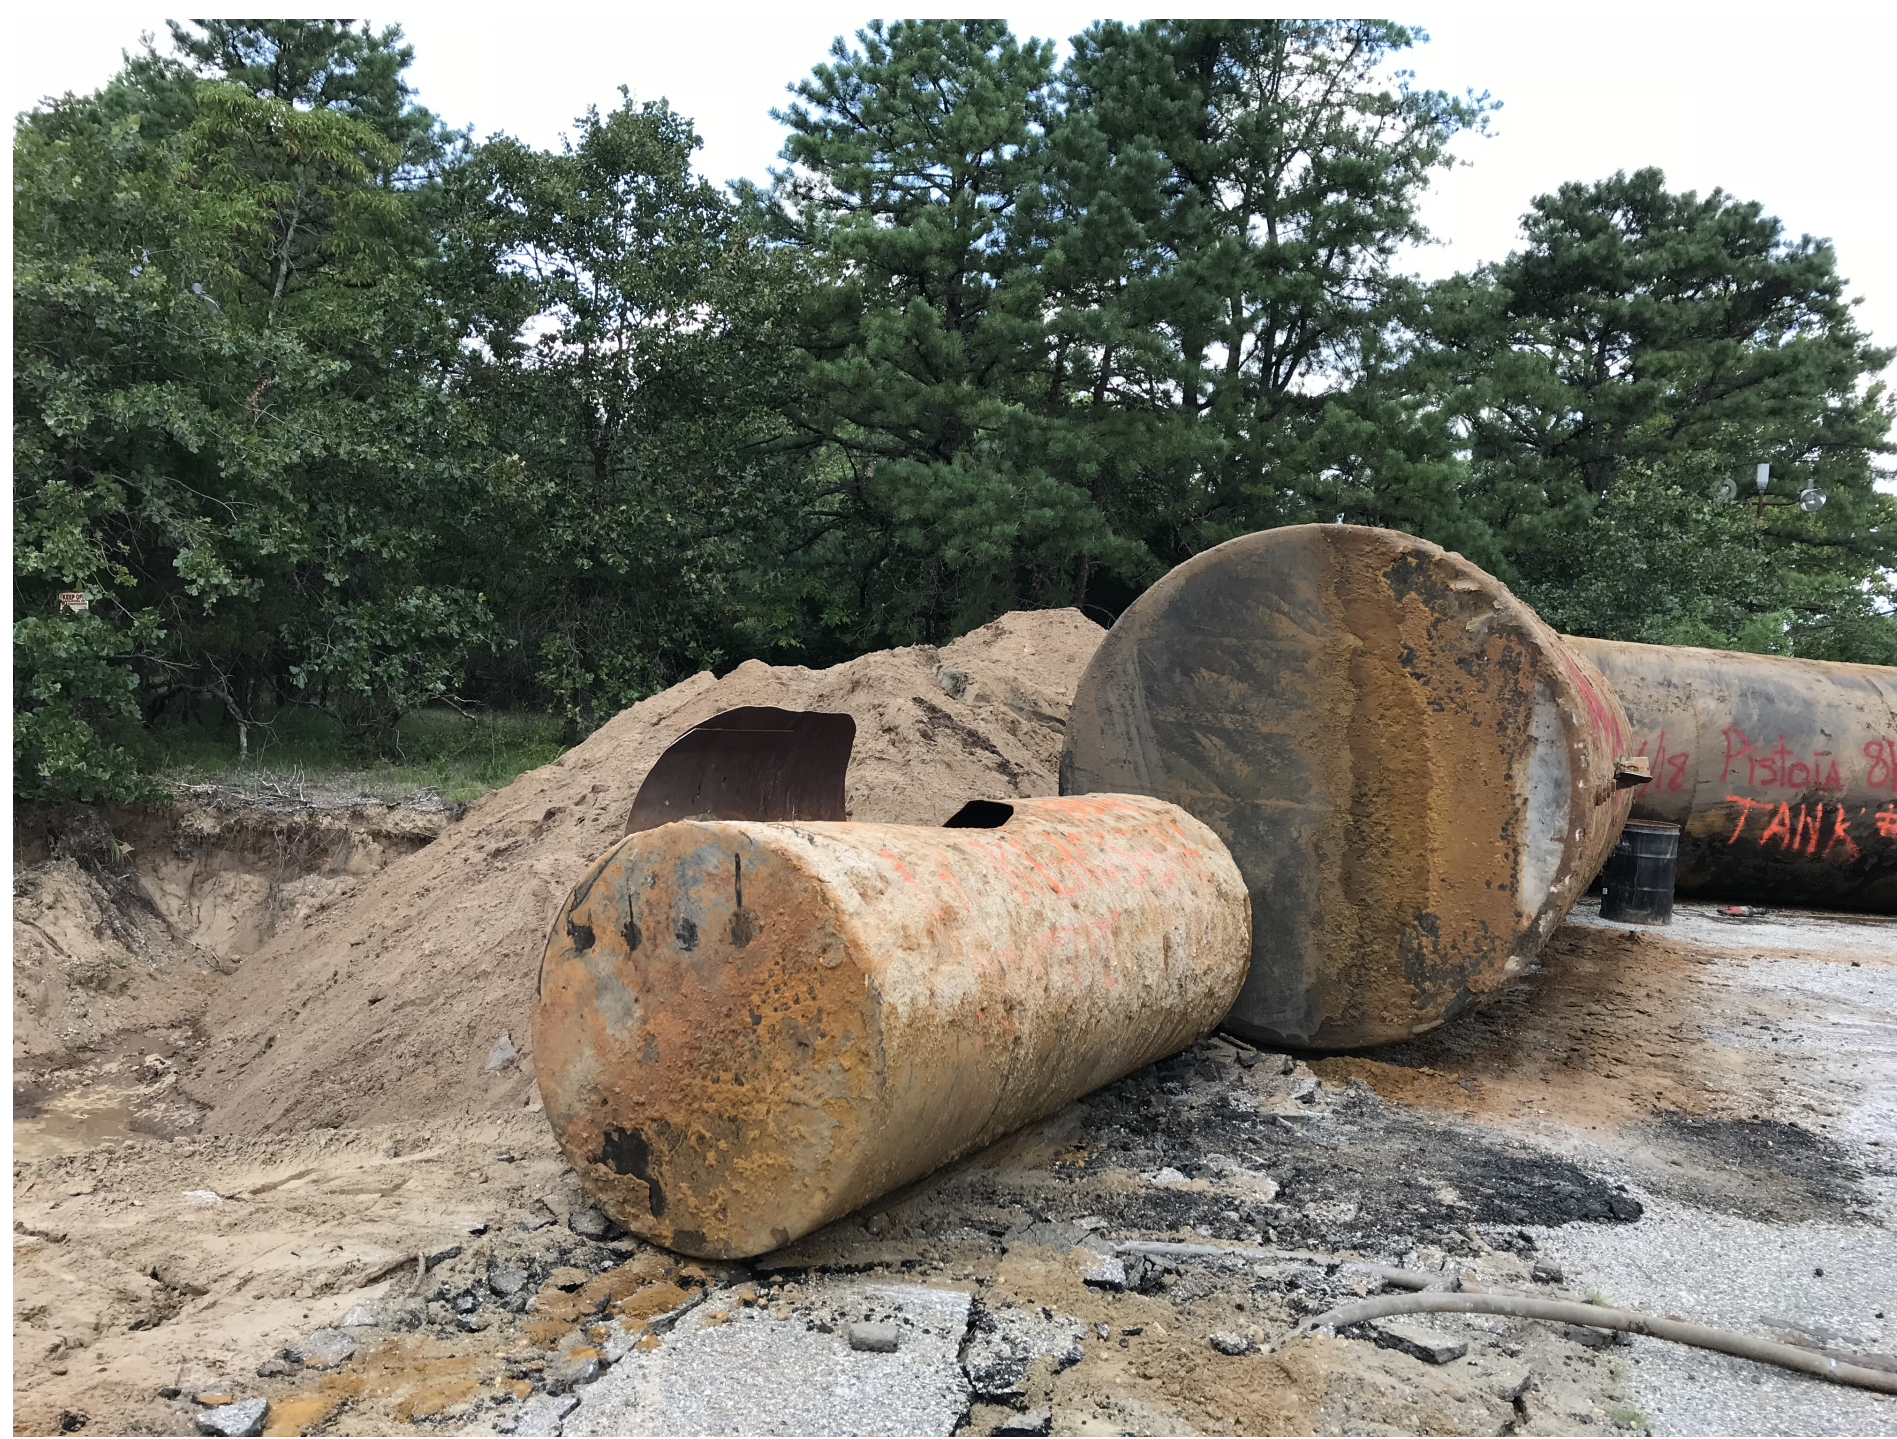
FIGURE 1

USTs removed

According to the official records the site had 5 USTs. However, while the tanks were being removed another tank was located, thereby adding to the project risk. The *in-situ* bioremediation treatment event using HydroRemed occurred on March 27, 2020, and the site was cleaned of total identifiable compounds (TIC) by December 2020. The process involved the following steps:

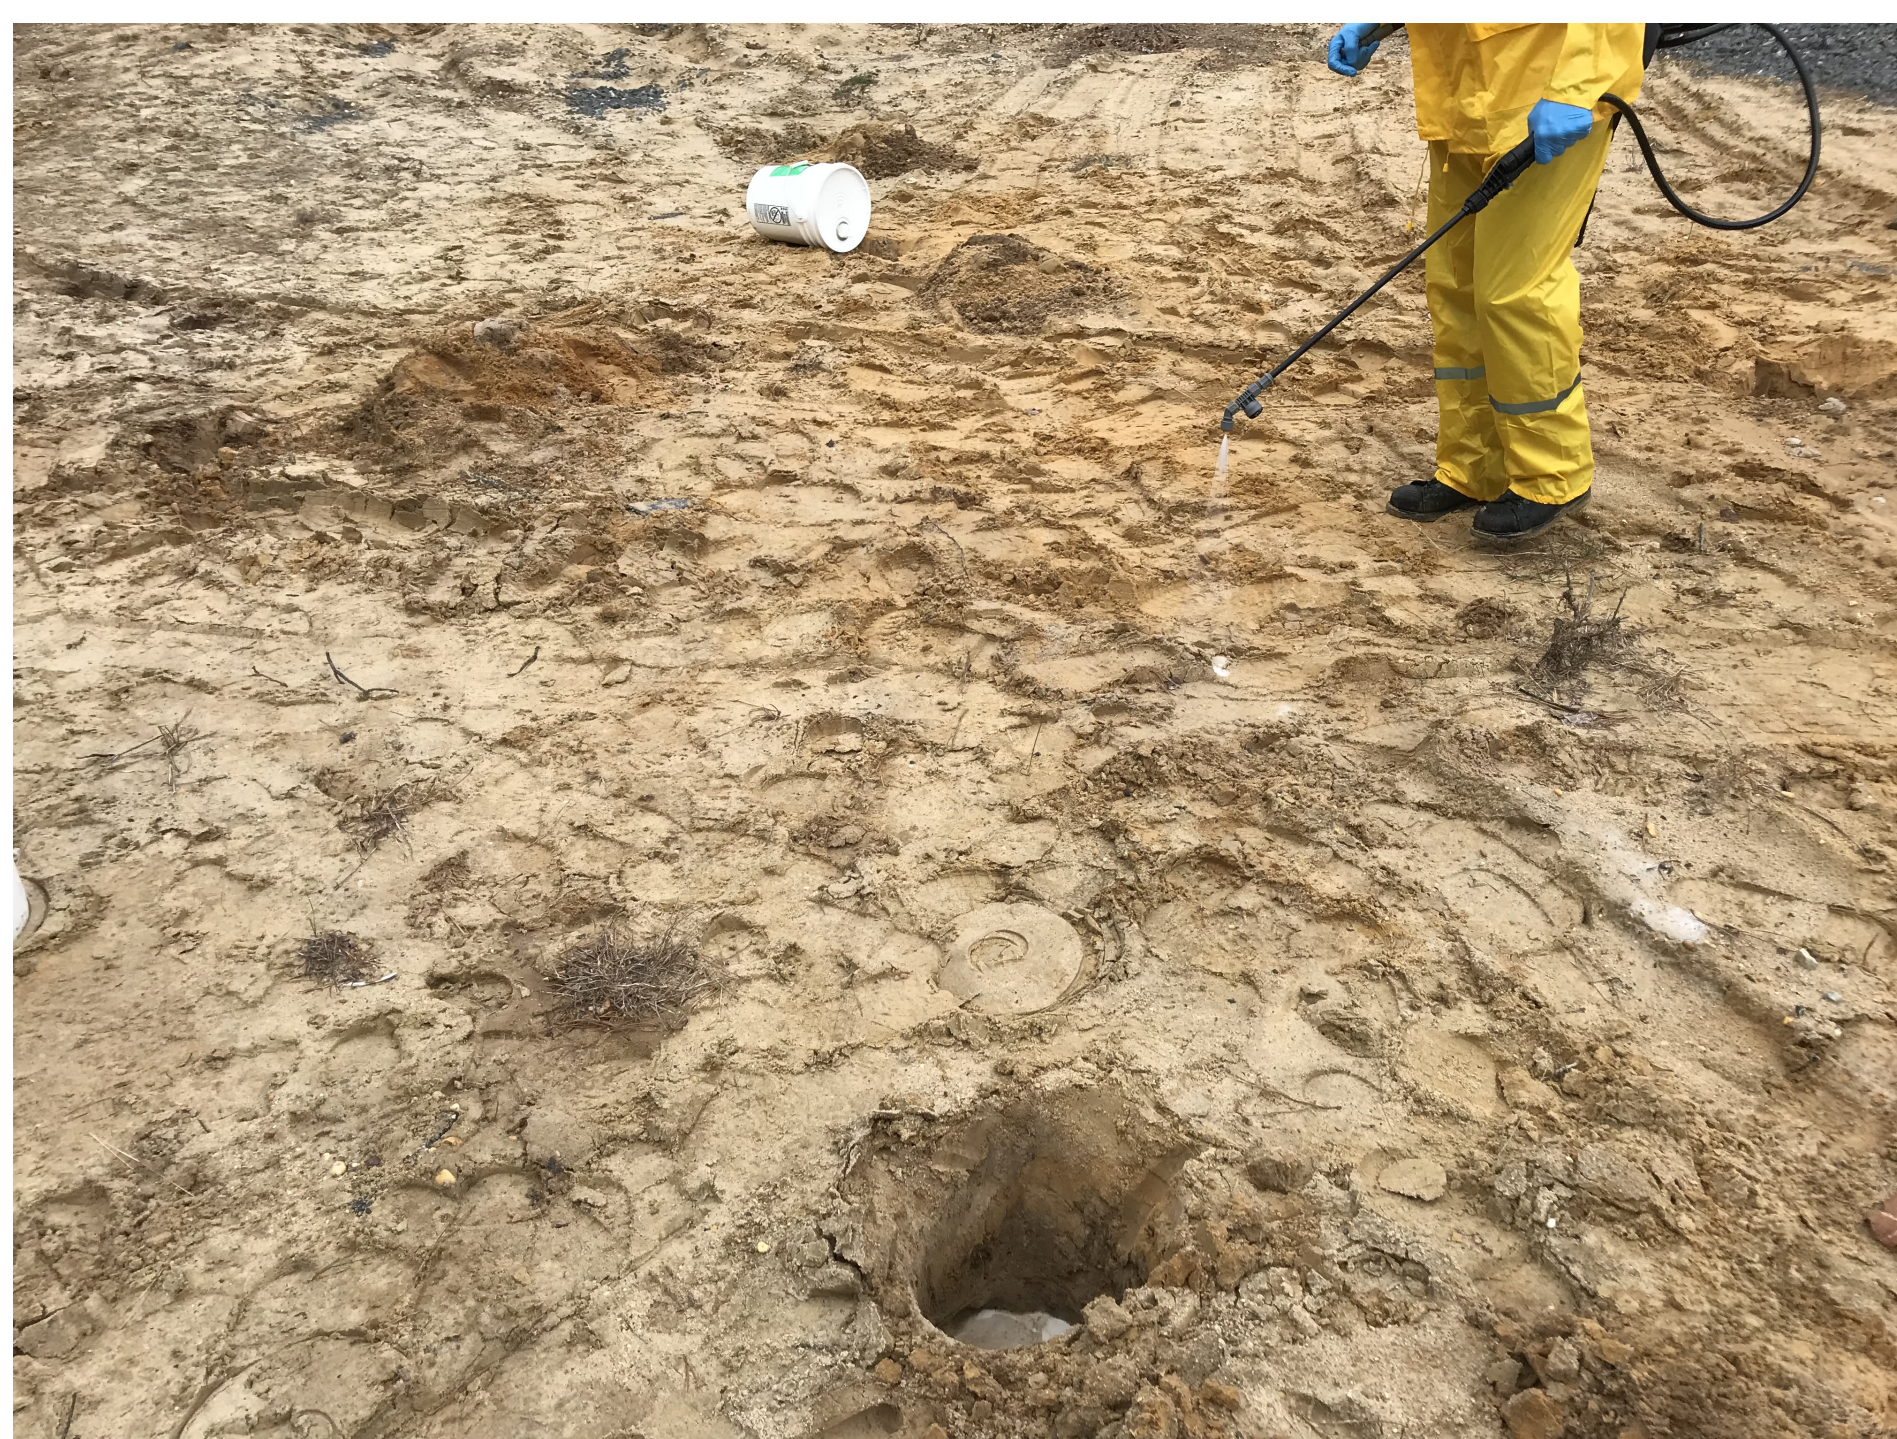
FIGURE 2

Remediation of groundwater with HydroRemed

The tanks were cleaned at the site before shipping them to the recycling station. Soil samples from each pit was collected and sent to the laboratory for analysis. HydroRemed was added to the groundwater in March 2020. In December 2020, the primary contamination due to BTEX was remediated. The year of 2021 was dedicated to monitoring secondary contaminants including Nitrogen and Arsenic. Subsequently, the site received Unrestricted Use Response Action Outcome (UU-RAO) in Jan 2022. Copies of the report are available on our website. <https://www.deeaarholdings.com>

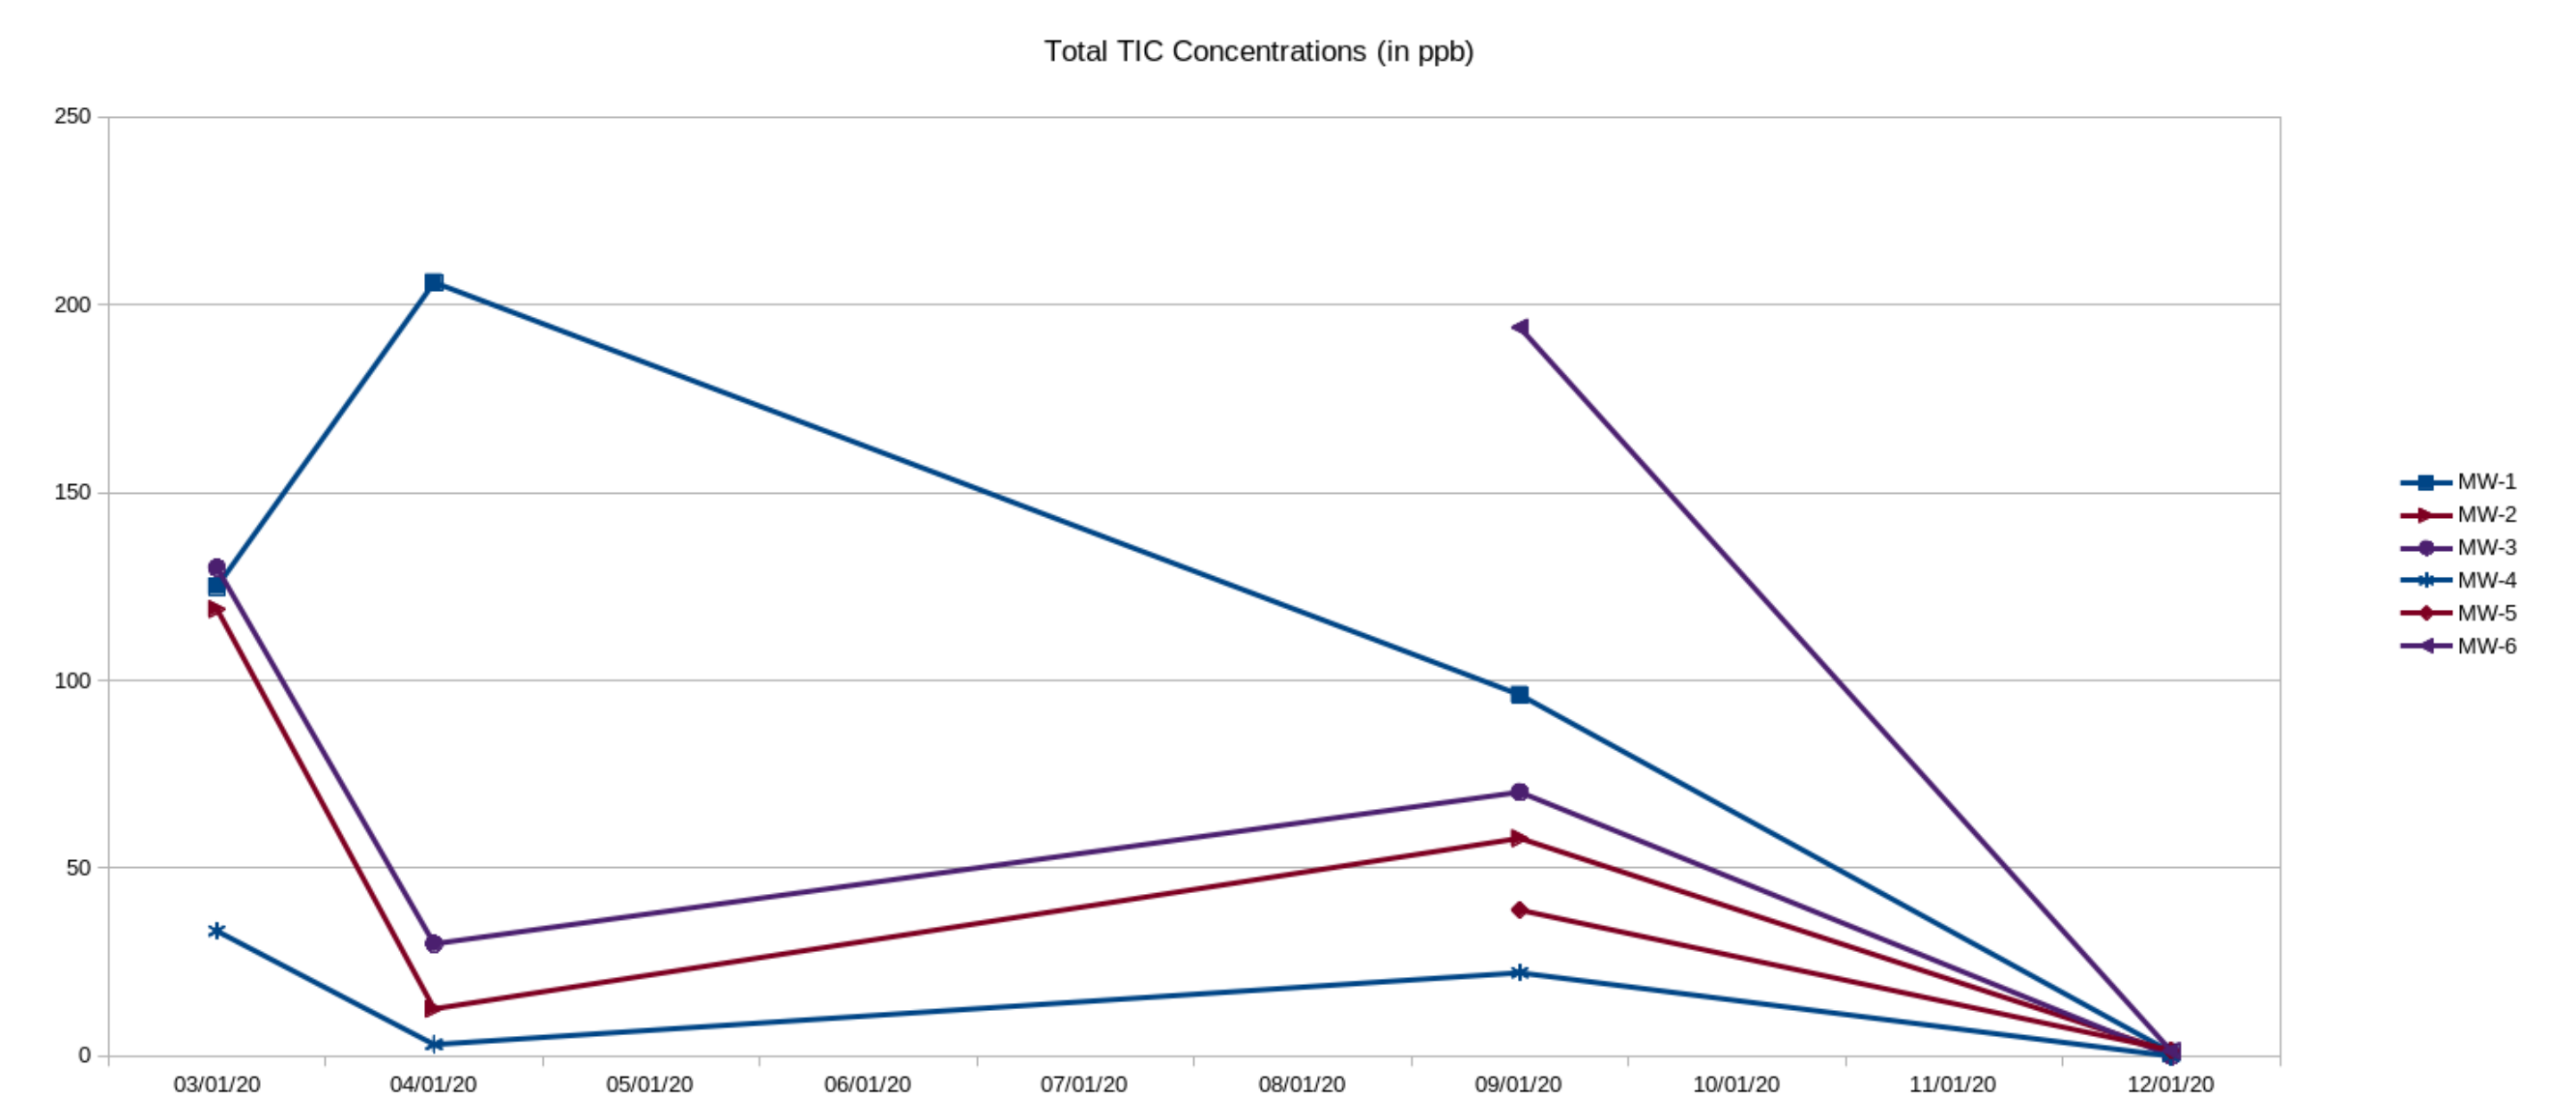
FIGURE 3

TPH degradation curve
